# MARINE LOG TRANSFER FACILITIES AND WOOD WASTE: WHEN DREDGING IS NOT YOUR FINAL ANSWER

# ABSTRACT

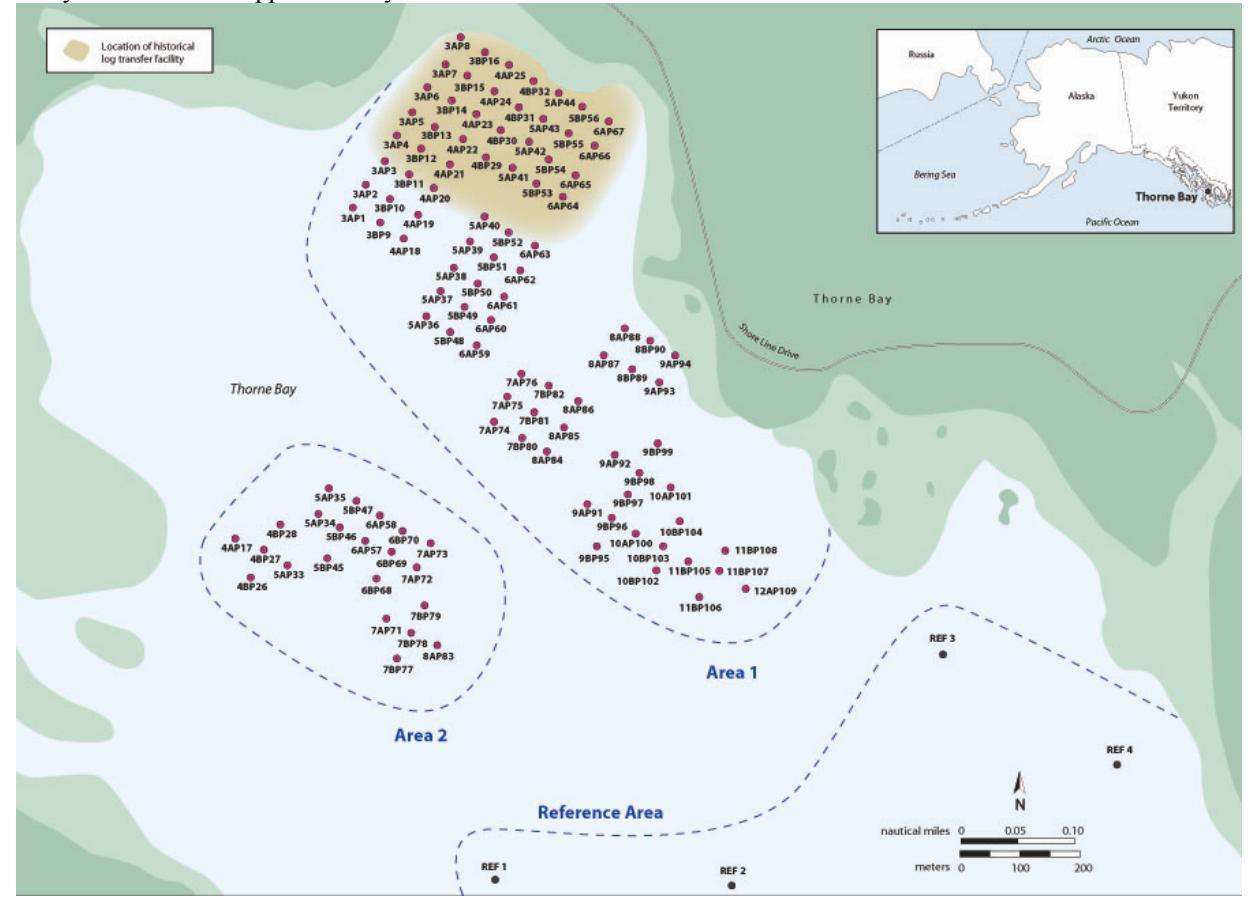
Figure 1. Sediment Profile and Plan View Imaging Stations Surveyed in Thorne Bay, June 2005

The 109 sample points established for the 2005 survey (Figure 1) were selected primarily to provide expanded characterization in areas that were identified in 2003 as having continuous wood debris cover; the total area surveyed in 2005 was approximately 76 acres.

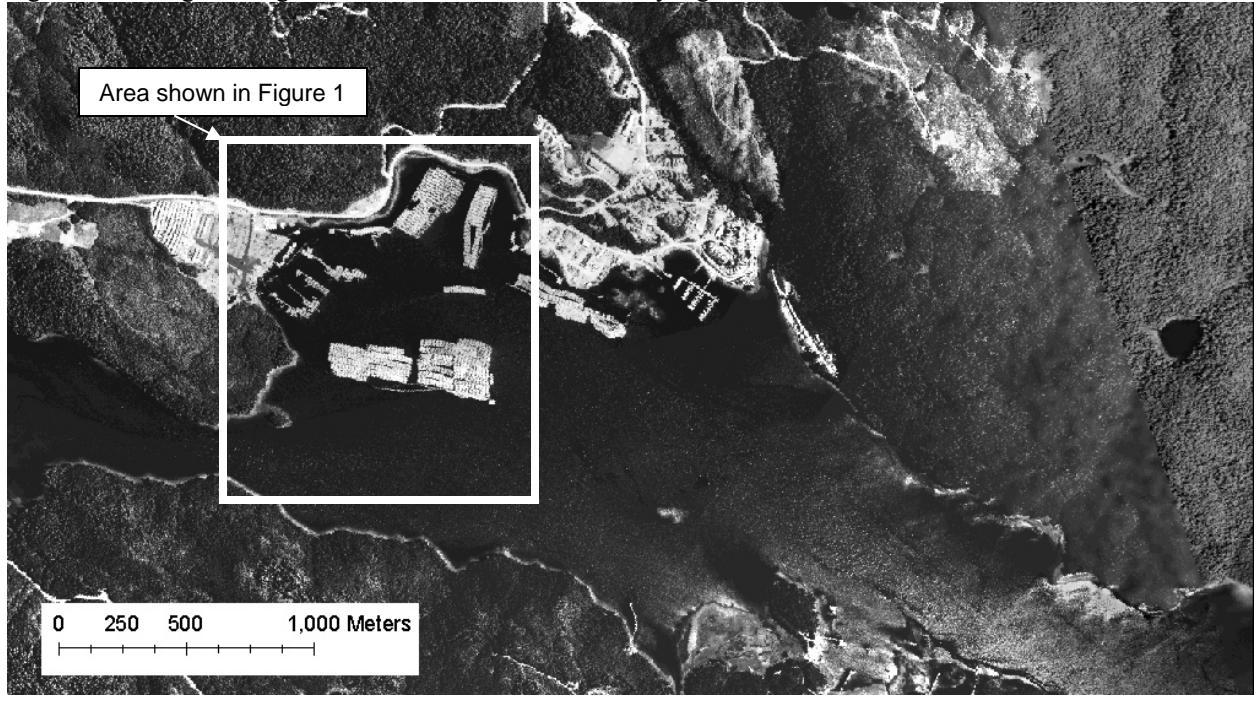
Figure 2. Historic Aerial Photo from the Late 1980's Showing Extent of Log Storage Rafts in Thorne Bay

A large volume of logs, estimated at 4.5 billion board feet, moved through the Thorne Bay site. Many of the logs harvested on Prince of Wales Island were trucked to the Thorne Bay LTF site, sorted and graded, placed in the water, and formed into rafts. Logs rafted elsewhere were towed into Thorne Bay, removed from the water, sorted and graded, and placed back into rafts. Prior to the mid 1970s, logs apparently were "flat rafted" as single floating logs enclosed within rafts. After that time, logs were cabled into bundles of 10 to 15 logs before placement into water, and remained in bundles until they reached destinations (Figure 2). Bundles prevented single waterlogged logs from sinking. All log rafts were towed to destinations by tug boats.

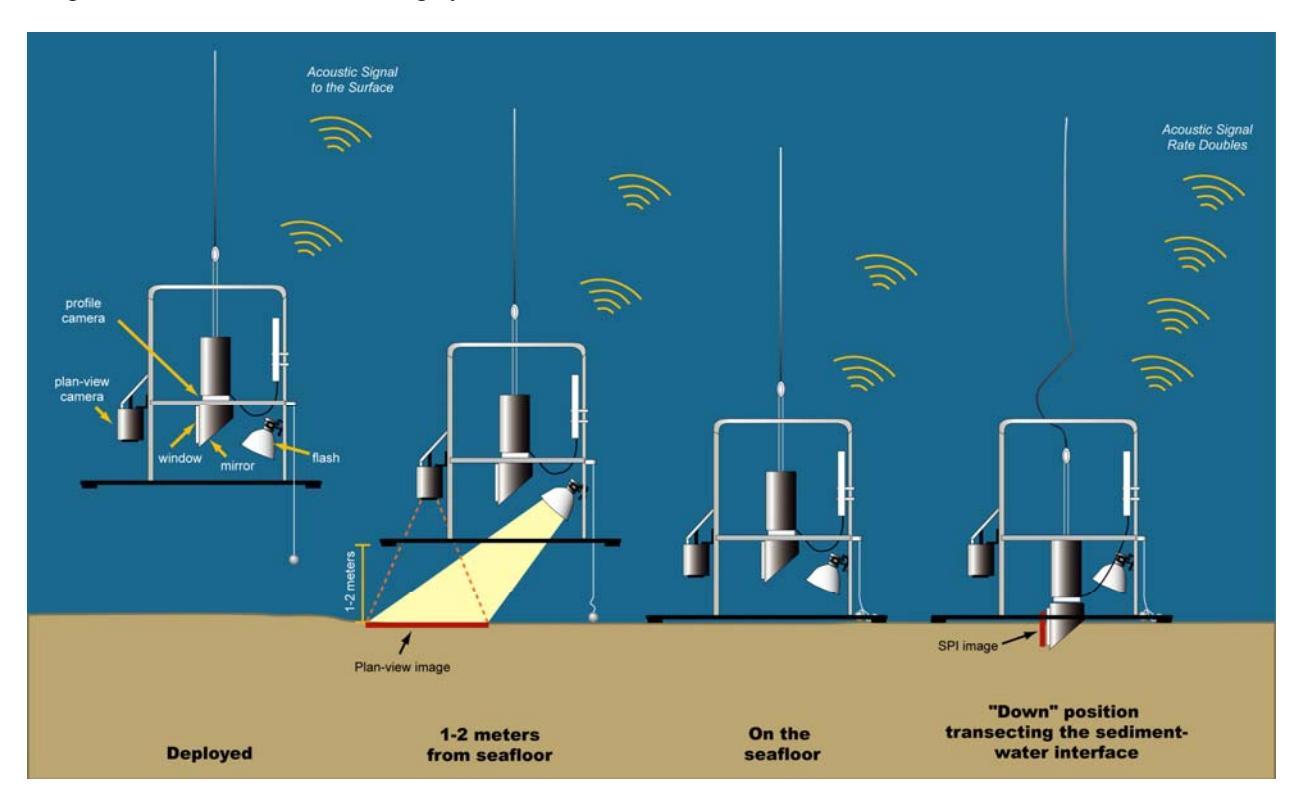
Figure 3: Operation of the Combined Sediment Profile and Plan-View Imaging Cameras

Sediment profile and plan-view images were collected at 109 site stations and 4 reference stations to characterize benthic community status and habitat conditions at and adjacent to the former log transfer area and compare them with conditions on the ambient seafloor (Figure 1). Sediment profile imaging (SPI) was developed almost two decades ago as a rapid reconnaissance tool for characterizing physical, chemical, and biological seafloor processes and has been used in numerous seafloor surveys throughout the United States, Pacific Rim, and Europe (Rhoads and Germano 1982, 1986, 1990; Revelas et al. 1987; Valente et al. 1992). The sediment profile camera works like an inverted periscope. The Ocean Imaging Model 3731 Sediment Profile Camera consists of a Nikon D100 6megapixel SLR camera with a 1-gigabyte compact flash card mounted horizontally inside a watertight housing on top of a wedge-shaped prism. The prism has a Plexiglas<sup>®</sup> faceplate at the front with a mirror placed at a 45° angle at the back. The camera lens looks down at the mirror, which is reflecting the image from the faceplate. The prism has an internal strobe mounted inside at the back of the wedge to provide illumination for the image; this chamber is filled with distilled water, so the camera always has an optically clear path to shoot through. This wedge assembly is mounted on a moveable carriage within a stainless steel frame. The frame is lowered to the seafloor on a winch wire, and the tension on the wire keeps the prism in its "up" position. When the frame comes to rest on the seafloor, the winch wire goes slack (Figure 3) and the camera prism descends into the sediment at a slow, controlled rate by the dampening action of a hydraulic piston so as not to disturb the sediment-water interface. On the way down, it trips a trigger that activates a time-delay circuit of variable length (operator-selected) to allow the camera to penetrate the seafloor before any image is taken. The knife-sharp edge of the prism transects the sediment, and the prism penetrates the bottom. The strobe is discharged after an appropriate time delay to obtain a cross-sectional image of the upper 20 cm of the sediment column. After the first image is obtained at the first location, the camera is then raised up about 2 to 3 meters off the bottom to allow the strobe to recharge. The strobe recharges within 5 seconds, and the camera is ready to be lowered again for another replicate image. Surveys can be accomplished rapidly by "pogo-sticking" the camera across an area of seafloor while recording positional fixes on the surface vessel. The resulting images give the viewer the same perspective as looking through the side of an aquarium half-filled with sediment.

An Ocean Imaging Model DSC6000 plan-view underwater camera (PUC) system was attached to the Model 3731 camera frame and used to collect plan-view photographs of the seafloor surface; both SPI and PUC photographs were collected during each "drop" (Figure 3). The PUC system consisted of Nikon D-70 encased in a titanium housing, a 24 VDC autonomous power pack, a 500W strobe, and a bounce trigger. A weight was attached to the bounce trigger with a stainless steel cable so that the weight hung below the camera frame. As the camera apparatus was lowered to the seafloor, the weight attached to the bounce trigger contacted the seafloor prior to the camera frame hitting the bottom and triggered the PUC (Figure 3). The ability of the PUC to collect usable images was dependent on the clarity of the water column. During the survey, abundant detritus was observed in the bottom waters throughout the site. This impeded the collection of clear PUC images as well as diver observations (Appendix B). To minimize the effects of turbid bottom waters, the bounce trigger cable was shortened as much as possible in order to decrease the distance between the camera focal plane and the seafloor. By limiting the amount

of water the camera had to see through, picture clarity was improved. One major drawback to the short trigger cable length and close distance between the PUC and the seafloor was that the field of view of the PUC system was decreased so that a smaller area of the seafloor was photographed. Even with the short trigger cable, many PUC images were not usable due to the highly turbid bottom waters.

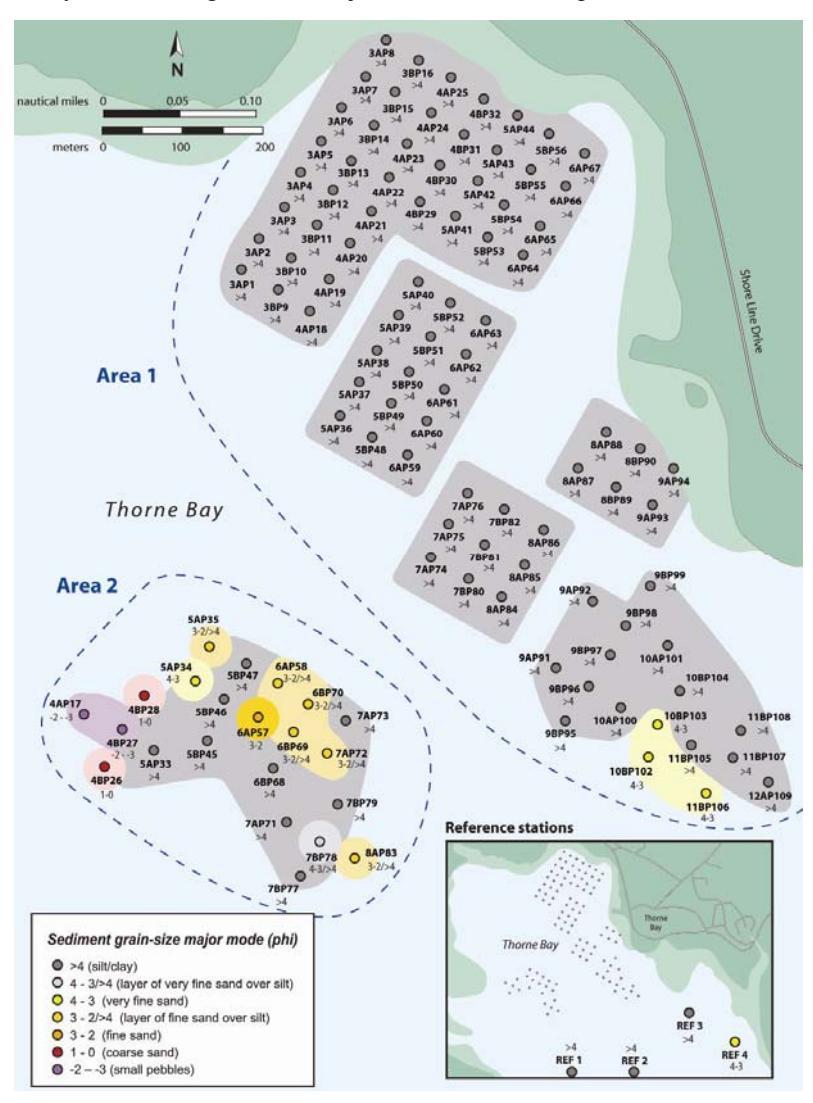
Figure 4: Sediment Grain-Size Major Mode (phi units)

Surface sediments in the survey area were primarily silts and clays (>4  $\Phi$ ; <0.063 mm major mode) with varying proportions of fine to medium sand mixed within the silt/clay matrix. In addition to typical lithic and clastic sediment particles, allochthonous particles such as wood, bark, and leaves along with authigenic biological particles such as shells were present within the sediment column at many stations. The distribution of sediment grain-size major modes from SPI images at site and reference stations is shown in Figure 4. It is important to note that wood residues were not considered when estimating grain-size major-mode. For example, if a station consisted of large wood particles in a silt/clay matrix, the grain-size major mode would be reported as >4  $\Phi$ , or silt/clays.

Eighty-three percent of the site stations were composed of sediments with a >4  $\Phi$  major-mode particle size. The northeast and eastern portions of the survey area, designated Area 1, were almost exclusively composed of silt/clays (94 percent of the stations). Small amounts of sand were present in nearly all stations. Although the base substratum remained consistent, the amount of wood and shell particles in the sediment column varied. In addition to the amount of wood and shell fragments varying, the distribution or location of these particles within the sediment column was also variable. The other notable characteristic of stations in Area 1 was that they often had a mantling of recently deposited detritus at the sediment-water interface (Figure 5).

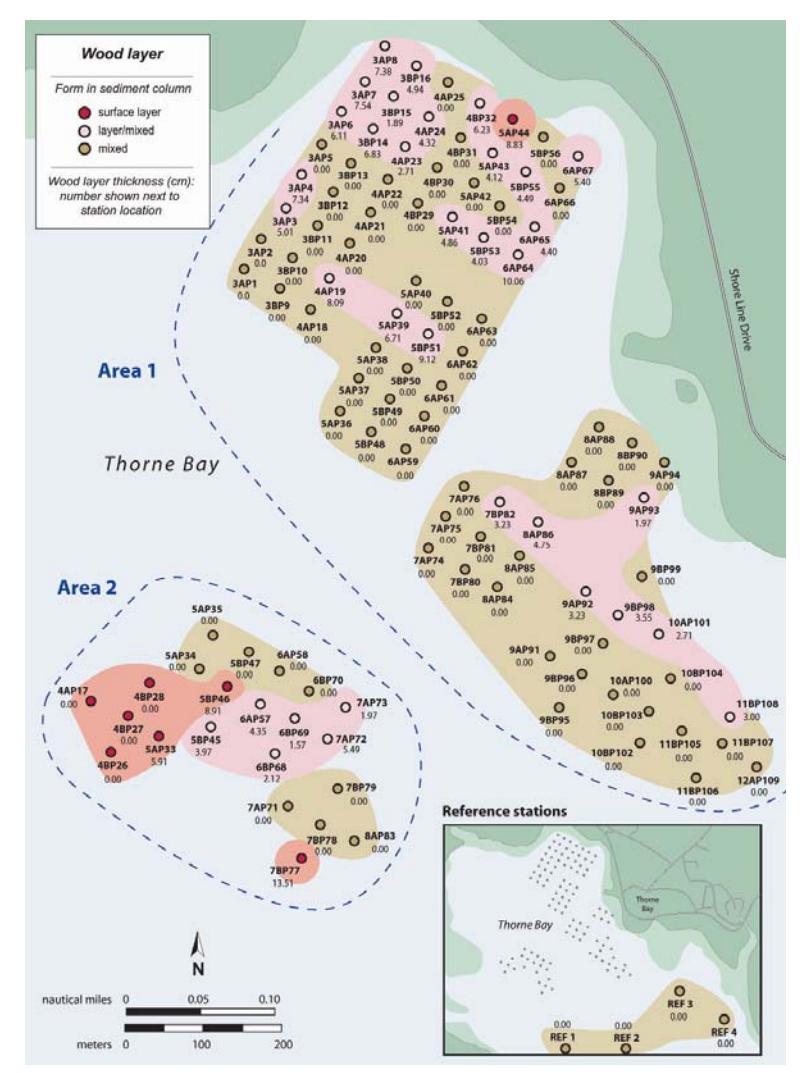
Figure 6: Distribution of depth and form of wood debris in Thorne Bay

To assess the amount and distribution of wood residues, the *in-situ* volume of wood residues within the sediment column was estimated by comparing observed wood particles in the SPI images to standard petrographic comparators (Browning 2004). In addition to the volume of wood residues in the sediment column, the maximum depth at which wood particles were present was measured, along with whether the wood particles were present as a distinct layer or whether they were admixed within the sediment column. The maximum depth of wood particles in the sediment column is presented in Figure 6 along with the location and form of wood residues in the sediment column.

Overall, 75 percent of stations exhibited wood particle content of 0 to 15 percent within the sediment column. Two groups of stations had higher wood residue contents. A group of stations in the far northeastern corner of Area 1 exhibited wood particle content of 15-30 percent, and one station contained 30-40 percent. A group in the southwestern portion of Area 2 exhibited wood particle content of 15-30 percent; three stations contained 50-100 percent (Figure 6).

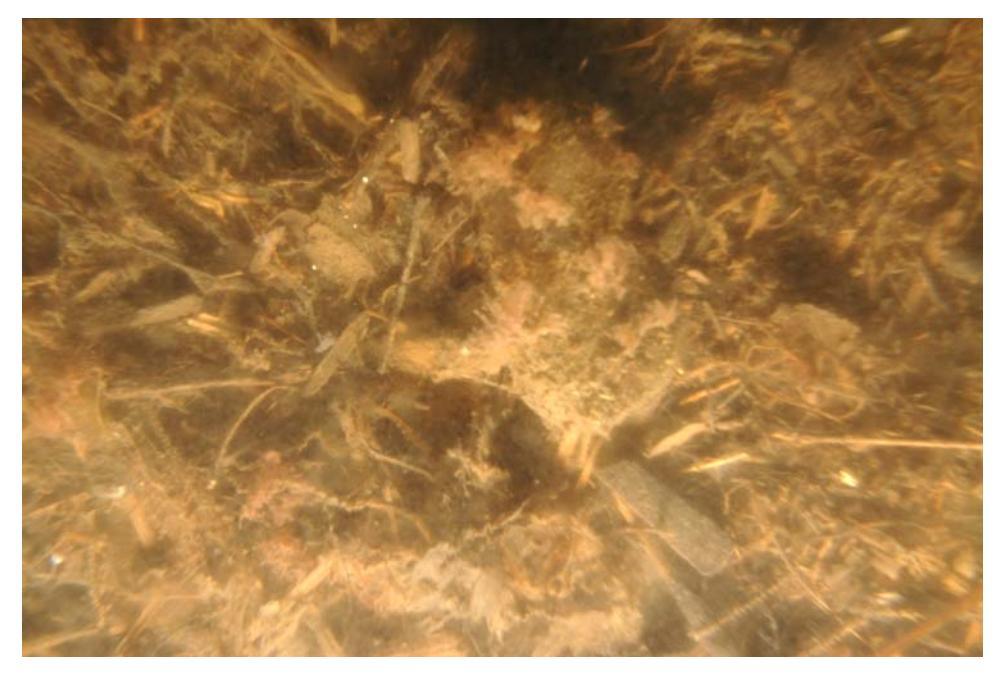
Figure 7: This plan-view image from Area 2 shows a mixture of wood fragments, sticks, needles and leaves. Scale of image = 33 cm by 50 cm (0.165 square meters).

Wood residues in Area 2 consisted of fragments of wood, sticks, branches, conifer needles and leaves (Figure 7). In addition, the wood residues were free of the detritus-mantling observed in Area 1 and also were colonized by epizoans and/or algae. Many of the wood particles such as conifer needles and sticks do not appear to be associated with log rafting and storage activities, but instead represent natural deposition of woody materials carried into the bay by either land run-off or through Thorne River fluvial processes.

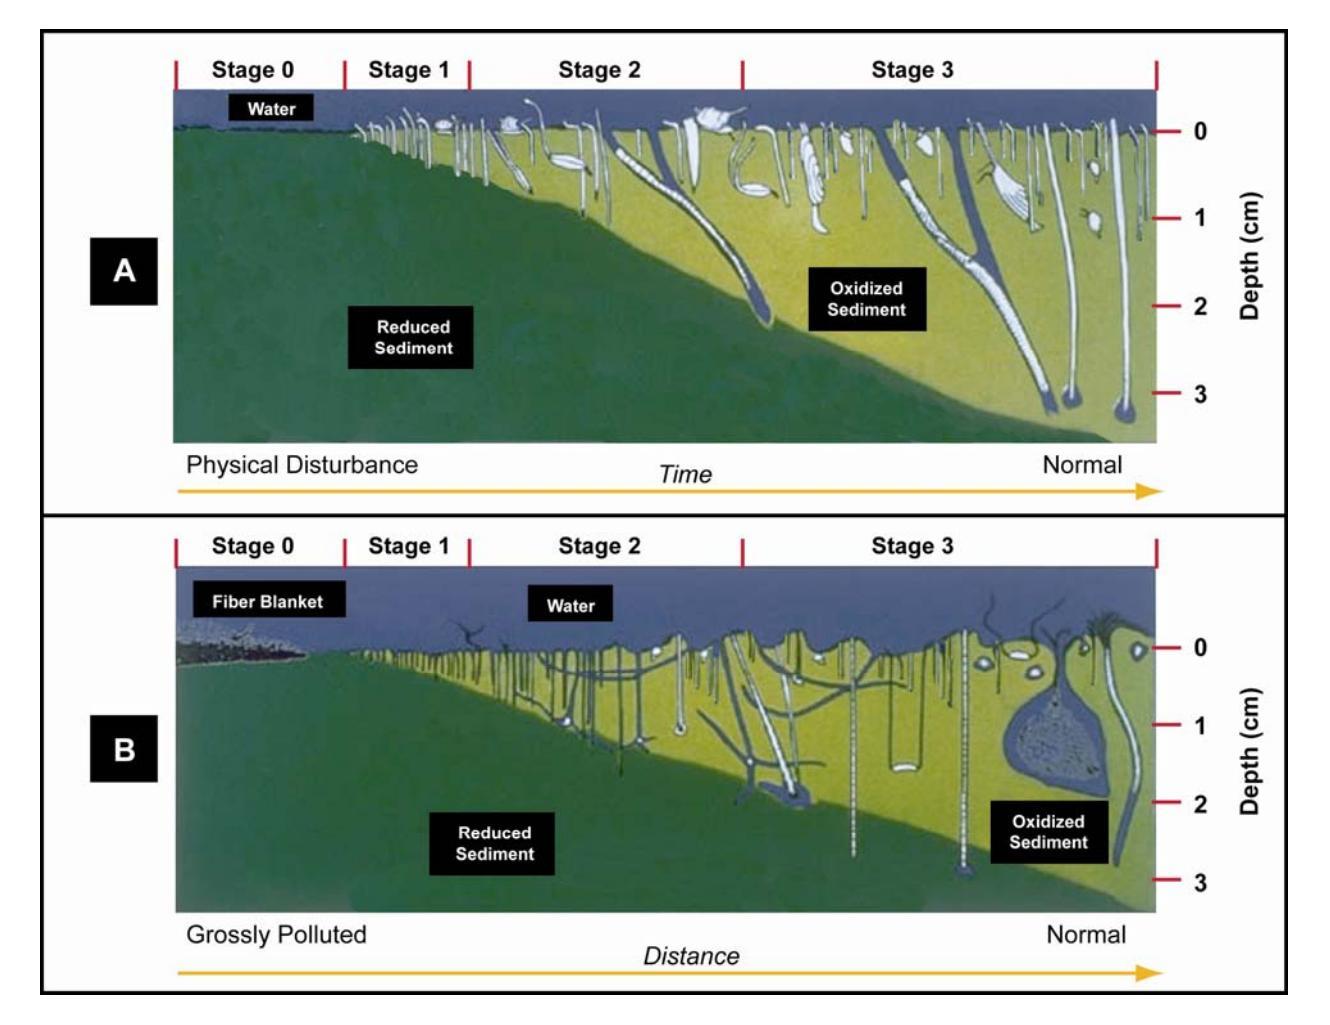
# Figure 8: Soft-bottom benthic community response to disturbance (top panel) or organic enrichment (bottom panel). From Rhoads and Germano, 1982.

taxon accounted for more than 4 percent of the total abundance. Total faunal densities per square meter at all stations ranged from approximately 1,200 to 4,200 individuals; the ranges for both the abundance and diversity of the faunal assemblages sampled at all 16 stations are typical for benthic communities that have recovered from organic loading stress and are at the tail end (Stage III) of the successional continuum (Figure 8).

While the north end of Thorne Bay had been placed on Alaska's 303(d) list as an impaired waterbody because of the presence of bark residues, there was not a single line of evidence of the multiple ones (sediment, infaunal community, or water column) investigated during the course of this study that showed any adverse impacts. While it is true that substantial amounts of bark or wood waste can have deleterious effects on the marine ecosystem (e.g., Pearson 1972; Conlan and Ellis 1979; Kurau 1975; Freese et al. 1988), it was also clear from the results found in this study that any adverse impacts from the past have long since disappeared due to sediment accumulation, decomposition of bark/wood residues, and the normal process of natural recovery and infaunal succession (Figure 8).

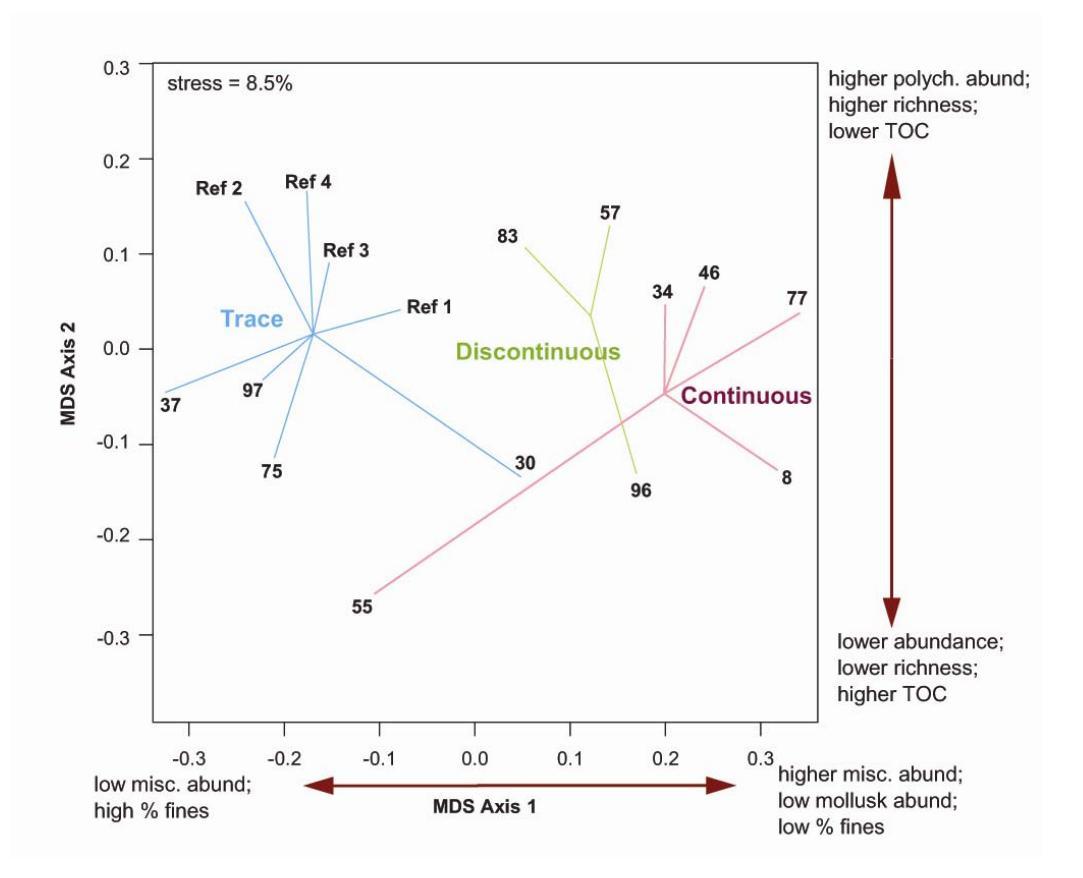
Results of the N-MDS analysis for 75 dominant species (comprising 90 percent of total abundance) are shown in Figure 9. This is simply a different way of portraying the distance relationships shown in the dendrograms from the cluster analysis. The DEC regulatory classifications for the amount of bark cover do not necessarily explain why the stations have clustered in the patterns shown.

An N-MDS analysis that included conventional variables BOD, COD and TVS resulted in very little change in the ordination pattern displayed in Figure 9. The only real differences when these conventional variables were added were:

- Stations 3A-P-8 and 5B-P-55 were more extreme on the negative end of the MDS2 axis, because they had higher TVS (which was strongly correlated with TOC).
- Stations 3A-P-8 and 5B-P-46 were less extreme on the positive end of the MDS1 axis; the basic relationship among all the stations stayed unchanged.

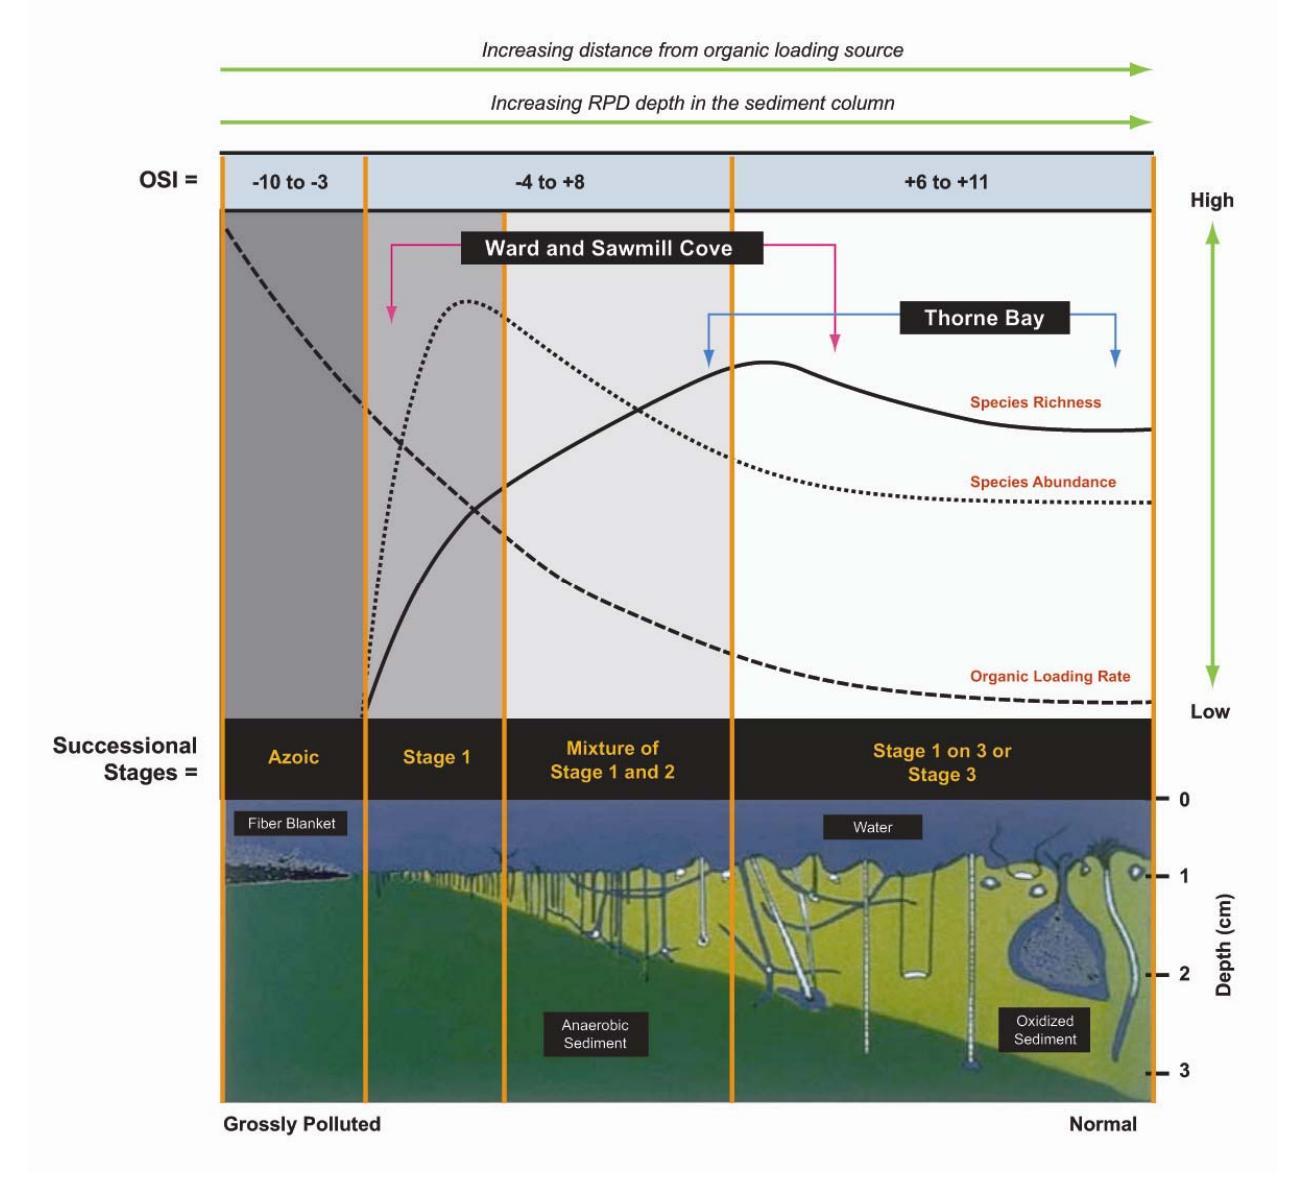
from 7 to 24 percent in 2004 (including reference stations; Exponent 2005) and 14 to 37 percent (EVS 1992). Total abundance values ranged from 200 to over 10,000 animals per m<sup>2</sup>, with the high abundance counts found at those stations in the early stages of recovery and occupied by dense assemblages of the opportunistic polychaete, *Capitella capitata*. At these stations, molluscs and arthropods were rare; polychaetes and nematodes were the dominant taxa. The Sitka survey also had organically enriched sediments with TOC concentrations ranging from 5 to 32 percent; while comparable species richness figures were not available (organisms were only identified to family), the benthic population densities ranged from 20 to 2,660 animals per m<sup>2</sup>. Various parts of the areas surveyed were in different stages of recovery; 16 percent of the area of concern was fully recovered (Stage III community), 22 percent was in transition (Stage II), and the remaining area was still in the very early stages of recovery (Stage I). It is important to note that the nature and quality of the wood waste in Ward Cove and Sitka are very different than that found in Thorne Bay. These other areas are affected mainly by pulp residues discharged from mill operations in addition to bark/wood debris from log rafting, while the wood residues in Thorne Bay are largely bark/wood debris from log rafting in Area 1 and natural riverine wood debris in Area 2. The relationship of organic loading on benthic community recovery is shown in Figure 10; as can be seen in this figure, the community in Thorne Bay is in a
